Marvell[®] PXA270M Processor

Specification Update

Doc. No. MV-S900957-00 Rev. I, PUBLIC RELEASE
April 19, 2010

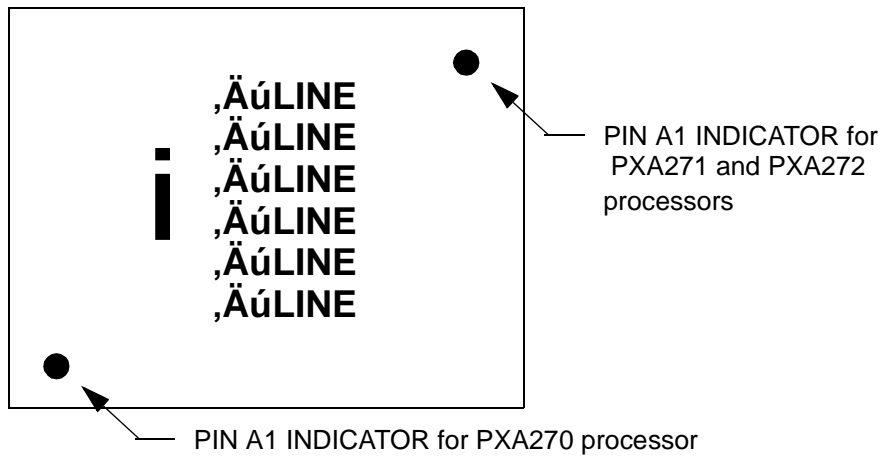
Figure 1. PXA27x Processor Family Package Markings Locations

The following figure depicts the location, on specific PXA27x Processor Family packages, where the actual markings are located.

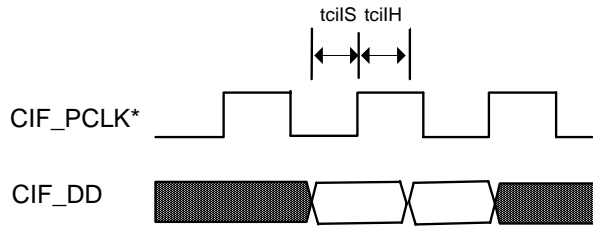
Figure 6-33. Quick Capture Interface Timing

Table 6-27 lists the timing parameters used in Figure 6-33.

Symbol	Description	Min	Typical	Max	Units
tcilS	Camera Interface Setup Time	5	—	—	ns
tcilH	Camera Interface Hold Time	5	—	—	ns

* CIF_PCLK Data Sampling edge determined by the CICR4[PCP] setting

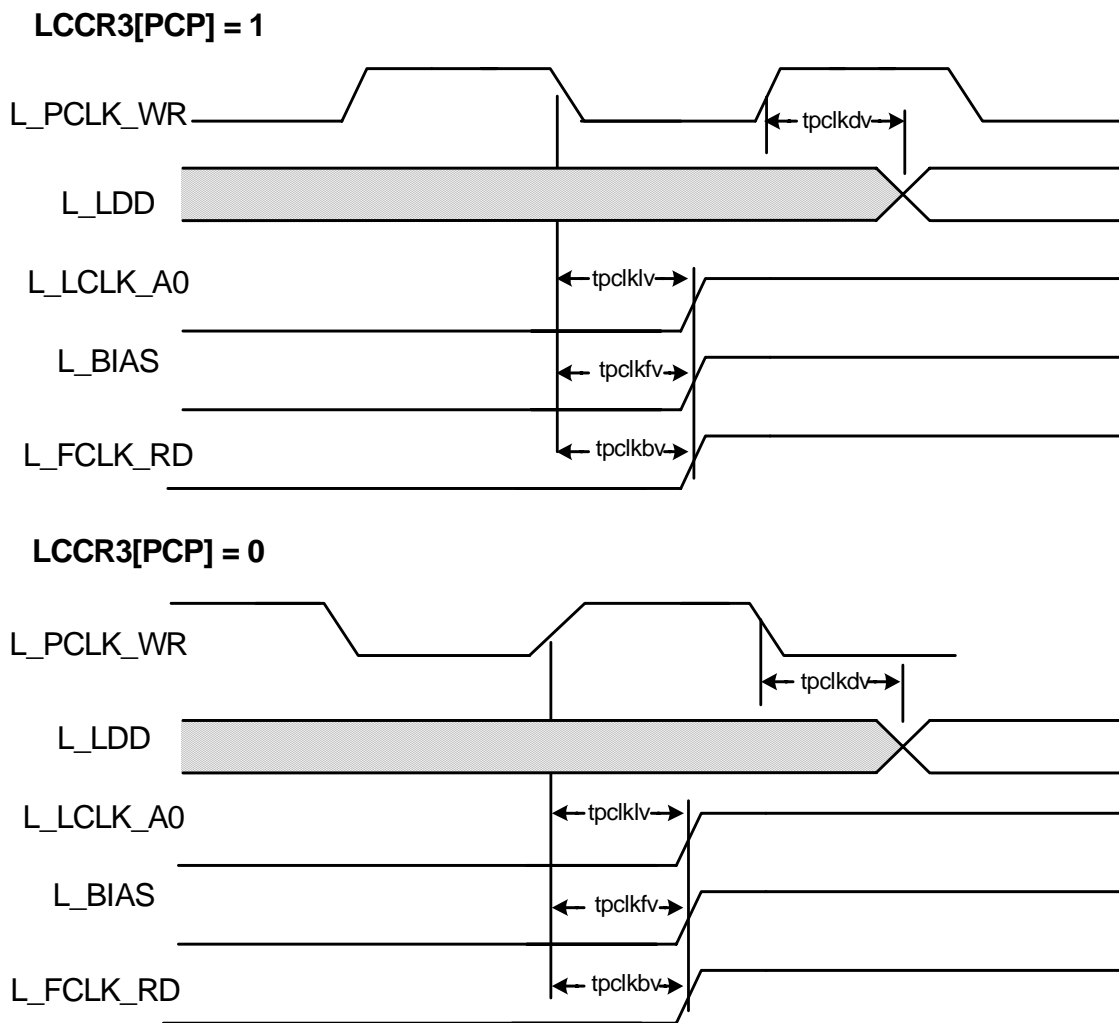
Figure 6-28. LCD Timing Definitions

Figure 6-28 should be replaced with:

In Table 6-22 LCD Timing Specifications of the PXA270 Processor Family Electrical, Mechanical, and Thermal Specification and PXA27x Processor Family Electrical, Mechanical, and Thermal Specification, the maximum values of Tpclkv, Tpclkv and Tpclkv should be updated. The associated Figure 6-28 LCD Timing Definitions should be updated to correct the timing relations relative to the LCCR3[PCP] setting.

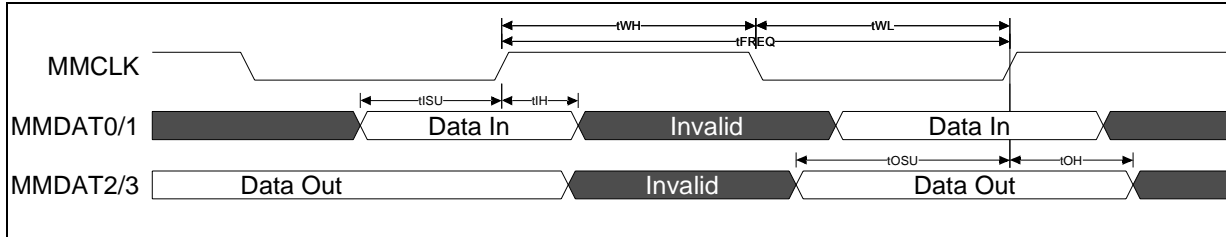
Figure 6-33. MultiMedia Card timing Diagrams

6.8 MultiMediaCard Timing Specifications

Symbol	Parameter	Min	Max	Unit	Notes
t_{FREQ}	MMCLK Frequency Data Transfer Mode	0	19.5	MHz	
t_{FREQ}	MMCLK Frequency Identification Mode	0	400	KHz	
t_{WH}	Clock high time	10	—	ns	
t_{WL}	Clock low time	10	—	ns	
t_{rise}	Clock rise time	—	10	ns	1
t_{fall}	Clock fall time	—	10	ns	1
t_{ISU}	Data input setup time	3	—	ns	
t_{IH}	Data input hold time	3	—	ns	
t_{OSU}	Output data setup time	13.1	—	ns	
t_{OH}	Output data hold time	9.7	—	ns	
NOTE:					
1. Rise and fall times measured from 10% - 90% of voltage level.					
t_{WH}	Clock high time	10	—	ns	
t_{WL}	Clock low time	10	—	ns	
t_{rise}	Clock rise time	—	10	ns	1
t_{fall}	Clock fall time	—	10	ns	1

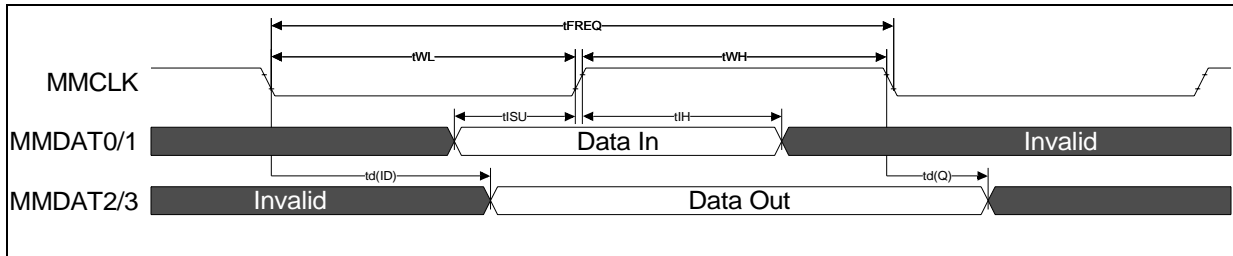
Figure 6-34. SD/SDIO timing diagrams

Figure 6-34 and Table 6-28 define the Secure Digital (SD/SDIO) controller AC timing specifications.

Symbol	Parameter	Min	Max	Unit	Notes
t_{FREQ}	MMCLK Frequency Data Transfer Mode	0	19.5	MHz	
t_{FREQ}	MMCLK Frequency Identification Mode	0 ¹ /100	400	KHz	
t_{WH}	Clock high time	50	—	ns	
t_{WL}	Clock low time	50	—	ns	
t_{rise}	Clock rise time	—	10	ns	2
t_{fall}	Clock fall time	—	10	ns	2
t_{ISU}	Data input setup time	5	—	ns	
t_{IH}	Data input hold time	5	—	ns	
$t_{d(Q)}$	Output Delay time during Data Transfer Mode	0	14	ns	
$t_{d(ID)}$	Output Delay time during Identification Mode	0	50	ns
